LESSONS LEARNED THROUGH COMMISSIONING, LIVENING, AND OPERATING SWITCHGEAR: PART 2

Copyright Material PCIC Europe
Paper No. EUR24_08

Abstract—The 500 MW expansion of a facility’s power system, incorporating 12 000 protective relays and modern technologies in a radial scheme and a breaker-and-a-half scheme, requires special attention. Potential errors during the constructing, commissioning, livening, and synchronizing of new facilities with an existing power system can lead to safety incidents and/or a loss-of-production event to the existing facility.

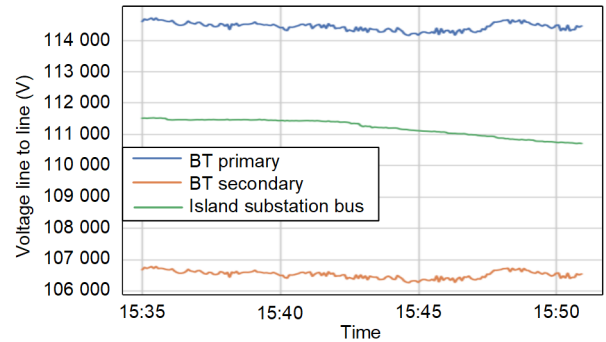
Fig. 3 Secondary voltage much lower due to tap position

dispatcher console is measured from the primary (utility-side) of the BT, whereas the autosynchronization controller is comparing the substation bus voltage to the secondary (facility-side) of the BT (refer back to Fig. 1). Indeed, the BT's tap, which is manually operated by power operations, was not in the 1:1 transformation ratio position, resulting in a significantly lower secondary voltage, as shown in Fig. 3. As such, the controller correctly tried to lower the island voltage.

After the team realized the problem, the dispatchers adjusted the tap position on the BT until the BT secondary voltage was closer to the substation bus voltage and returned the participating GTG back to a typical terminal voltage. The team reinitiated the autosynchronization, which sent no further GTG signals since the island voltage and frequency were now within the closing range. After waiting for the angle difference to come within the closing range, the system closed the utility breaker, and the facility was resynchronized, as shown in Fig. 4.

- Ensure the operating procedure begins with verifying the BT tap changer position, and, if necessary, change the tap position such that the BT secondary voltage is within a synchronizable range.
- Add a communications link to display both the utility-side and facility-side BT voltages on the dispatcher console.
- Add a blocking signal from the generator secondary control system to block autosynchronization raise or lower signals for an individual GTG if terminal voltage limits would be exceeded. (The transmission of a similar blocking signal from the governor had already been configured if speed or real power limits would be exceeded.)

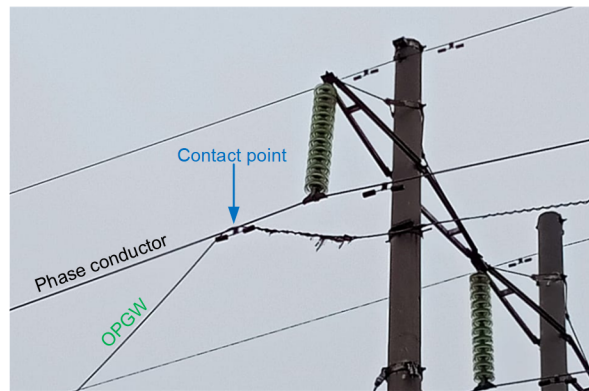
Fig. 15 Broken OPGW contact with C-phase conductor

Upon review of the relay event reports confirming presence of a legitimate power system fault, the team conducted a walkdown of the transmission line. The OPGW was found to be broken on one of the transmission poles. This OPGW carried the line current differential fiber for the redundant line differential channels of the line relays. When it broke, it caused failure and disabling of the line current differential channel. This demonstrates the importance of routing each fiber channel in two physically separated paths. Alternately, an existing communications network and multiplexing technologies, such as a synchronous optical network (SONET), can be leveraged to establish a secondary line differential channel to complement a primary dedicated line differential channel [5].

The picture shown in Fig. 15 was taken during the walkdown of the tripped transmission line. The figure shows that the broken OPGW, which was suspended on one of the poles, had contacted one of the phase conductors. This established a sequence of events in which the initial report related to the bad utility circuit breaker was caused by the breakage in the OPGW. Then, a protective trip followed due to the broken OPGW making contact with one of the phase conductors.

This event highlights the importance of monitoring the line current differential channels and generating alarms in case of a channel failure. A line current differential channel failure alarm would have asserted in this case and allowed the system operators to address the issue before the broken OPGW caused a line trip. Additionally, [1] describes advanced reporting functionalities that can be implemented in line current differential relays to enhance monitoring of the communications channel.

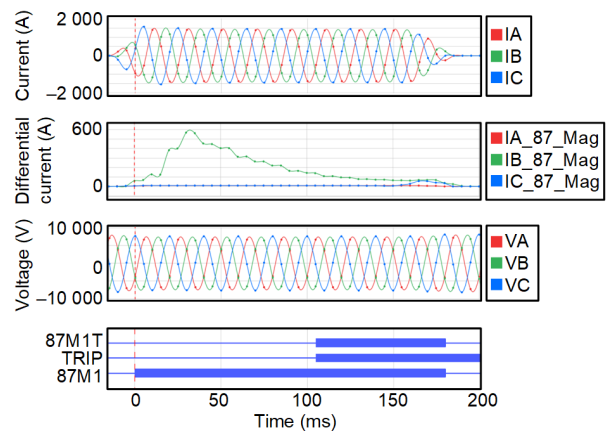
Fig. 17 Initial start filtered event report

To analyze the unexpected differential trip, the commissioning team reviewed the event report generated by the relay. See Fig. 17 for the filtered event of the initial start and Fig. 18 for the raw or unfiltered event report of the same motor start. The event reports show an increase in current on the B-phase differential current, which results in

a trip 100 ms later. Based on the voltage waveforms (relay connections also include bus-side voltage inputs), however, there was no B-phase-to-ground fault on the power system. The current magnitude was also decreasing in the differential circuit leading up to the trip. This decaying differential current is a sign of false differential current and led the commissioning team to suspect CT saturation [6]. Raw or unfiltered event reports allowed the commissioning team to confirm CT saturation as the root cause.

For this 10 kV motor application, 87 differential protection consists of source- and neutral-side CTs. In this case, the switchboard supplier was a different manufacturer than the motor manufacturer, and the CTs were not of the same type or manufacturer as normally recommended for 87 differential protection [7]. In addition, the distance between the relay and the switchboard feeder CTs was less than 3 meters, while the distance from the relay to the motor neutral end was over 200 meters. Differences in lead length also compromise differential protection [7].

The differential current waveforms in Fig. 17 and Fig. 18 are classic signs of dissimilar CT performance. After a discussion with engineers, it was agreed to extend the 87 differential start pickup trip time to 500 ms and maintain the existing set point to permit a start. With the relay set to generate an event report when the 10 kV breaker changed state, the following waveform was captured during the successful start. Fig. 19 shows the filtered event report. In this case, the motor successfully started, but the false 87 differential current lasted for 364 ms. To make the relay secure during start, the starting differential element needs to account for this expected fault differential current. From the relay's sequential event report and motor start report, the motor remained in the starting state for approximately 2.5 s during this uncoupled run. From motor nameplate information, however, a normal coupled load start for the motor is expected to take 9 to 17 s, depending on the voltage (100 to 80 percent nominal voltage, respectively).

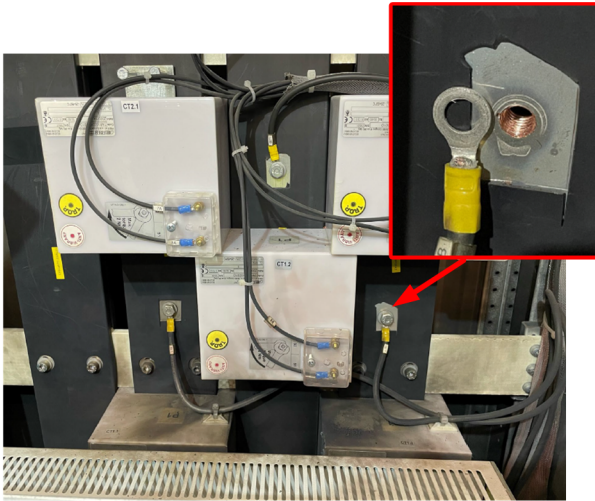
Fig. 21 Postmanufacturing drilled holes on the 380 V busbar

Upon an intrusive post-event inspection of the MCC, copper shavings, which were hardly visible during the general visual inspection, were found at the rear of the circuit breaker busbar connections. The copper shavings were suspected to be left over from a retrofit installation of a voltage transformer on the busbar, which occurred in the fabrication yard where the module was constructed. There were threaded holes drilled on the busbar to accommodate installation of the voltage transformer. Fig. 21 shows the drilling point on the copper buses for the installation of the new voltage transformer. Many copper shavings were found inside the breaker compartment. It is suspected that one of the shavings fell down on the busbar due to breaker jolt while closing and resulted in the arc-flash event.

The major lesson learned from this event was to implement a thorough housekeeping plan as part of the prechecks prior to energizing equipment for the first time for cleanup of any debris accumulated during the construction and commissioning phases. As this event proves, a thorough housekeeping of the switchgear would have discovered the copper shavings inside the breaker compartment and prevented this incident from happening.

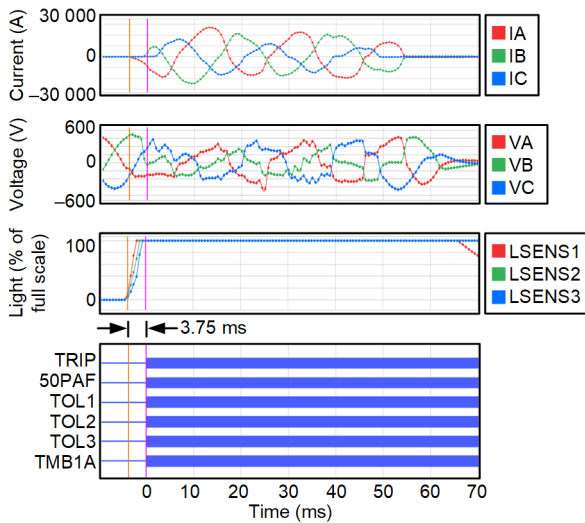
Fig. 22 380 V incomer relay response to an arc flash

Fig. 22 is a screenshot from the event report, which was triggered by the incomer relay for the arc-flash trip. The third waveform from the top shows the single-phase voltage input from the busbar. This is the most accurate representation of the time the breaker was closed. For reference, the digital chart at the bottom shows the breaker status feedback (52a) that arrived in the relay about half a cycle after the appearance of the bus voltage. Shortly after the breaker was closed, the phase voltages became distorted and currents jumped to fault levels.

As shown in the digital chart at the bottom of Fig. 22, both the over-light and overcurrent conditions were detected about 4 ms after fault inception (appearance of fault current). The TRIP output was issued within the same relay processing cycle to trip the incomer breaker. The upstream breaker tripped 54 ms after the trip command was issued for a total clearing time of 58 ms. Note that for the timing measurements mentioned previously, the fault inception is considered as the first appearance of fault currents and the breaker opening is defined as the time that the currents were reduced to zero.
