# Co-Simulation: Unlocking Advanced Approaches to Electrical Incident Analysis

Copyright Material PCIC energy  
Paper No. PCIC Europe EUR26\_24

Julien Mécréant  
Schneider-Electric  
Grenoble  
France

**Abstract** - Ensuring electrical reliability is key for Oil & Gas facilities, where process continuity and safety are essential. While outages are rare, when they occur, root cause identification is complex due to multiple interacting factors. Immediate restoration takes priority, leaving incomplete data for post-event analysis.

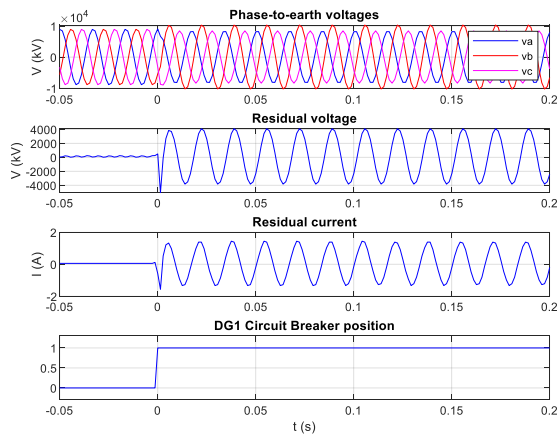
Fig. 6 DG1 relay waveforms during an unsuccessful reconnection

Voltages were measured on the generator side (upstream of the breaker). Before  $t = 0$ s, the generator was not yet connected, and the phase-to-earth voltages were balanced and equal to the rated voltage. At  $t = 0$  s, closing onto the busbar caused phases 1 and 3 amplitudes to decrease while phase 2 increased. Measured frequency remained stable and cannot explain ANSI 24 operation.

A residual current of around 0.94 A (vs. 7 A earthing per generator) and a residual voltage appeared at closing, which could suggest a resistive earth fault. However, in a usual single phase-to-earth fault, only the faulted phase drops while the healthy phases rise towards line-to-line; this was not observed. A double earth fault (also called cross-country fault) could have this pattern, but it would require both faults to be very high impedance - unlikely with all MV feeders disconnected.

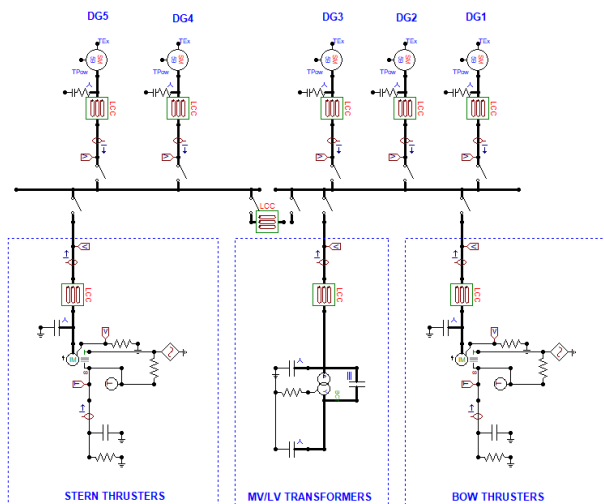
Fig. 9 Schematic diagram on EMT-ATP power systems software

In order to get more accurate result and to evaluate the impact on the ANSI 24 protection, a portion of the network was modelled in EMT-ATP power systems software. The EMT-ATP model is presented in Fig. 9.

All main electrical parameters were known, making the analysis possible. The partially open thruster breaker was represented with one pole closed and two poles open. Simulated quantities are compared with field measurement. (Fig. 10).

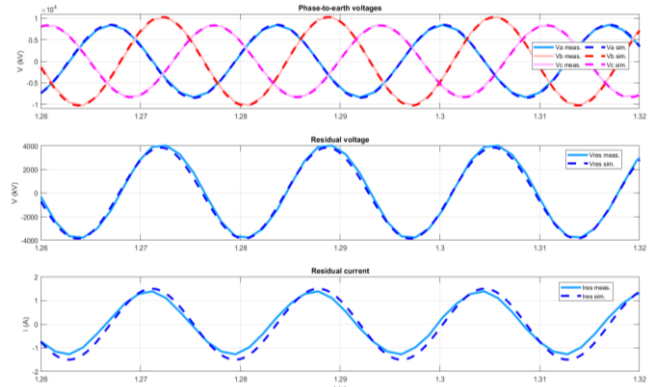
Fig. 10 Comparison between simulations and real signals

This confirms both the correctness of the physical understanding of the phenomenon and the validity of the simulated model. The next step consists in verifying that the ANSI 24 protection operates consistently with the measured signals for all the operating modes.

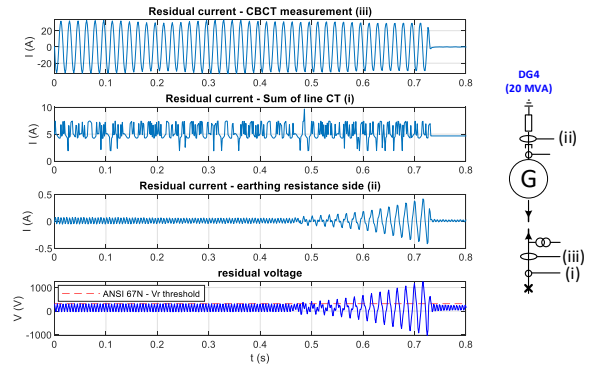
Fig. 12 DG4 recording file during earth fault tripping

At the beginning of the record, the core-balance CT measured around 20 A residual current while residual voltage was negligible (measurement accuracy only). Given the neutral earthing system (7A per generator connected – 4 generators connected), 20 A residual current would imply a solid earth fault, with residual voltage near three times the rated phase-to-earth voltage. The measurement inconsistency is typical of a core-balance CT installation issue. Most often, cable screen earth braids do not pass correctly through the CBCT (omitted or reversed). Screen currents (including induced current) are not balanced on the three phases and are proportional to the phase current. It could create a false residual current if the screen is not properly pass through the CBCT as shown in Fig. 14.

At the same instant, the phase-sum residual current was around 0 A (only noise is measured with a level consistent with 1000/1A CT ratio) and no current is measured through the CT installed at the neutral earthing resistance side, confirming a wiring/installation problem on the CBCT. Until then, the problem had no operational impact: although the false residual current exceeded the ANSI 67N current pickup (set to 2 A), the residual voltage was below 2%  $V_{LL}$  (Line to Line voltage) (as shown in Fig. 12). When the bow-thruster breaker opened on two polarities, residual voltage appeared and ANSI 67N tripped spuriously.

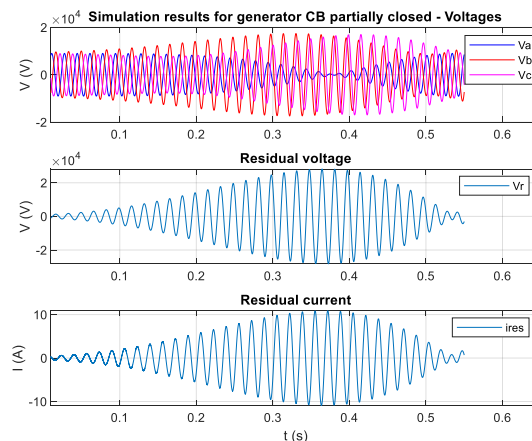
Fig. 15 Electrical network behaviour in case of generator CB partial opening – simulation results.

Subsequently, to gain further insight into such an event and to develop potential protection schemes capable of detecting a partial circuit-breaker opening, additional simulations were performed considering any circuit breaker in the installation as potentially failing. In the case of a generator circuit-breaker failure, the phenomenon produces highly atypical voltage signals (Fig.15), significantly different from the scenario in which the bow-thruster circuit breaker remained conducting on one phase. Among other aspects, the voltages exhibit oscillatory behaviour, the residual current amplitude is not constant, and it exceeds the pickup threshold of the ANSI 51N protection implemented on the generators.

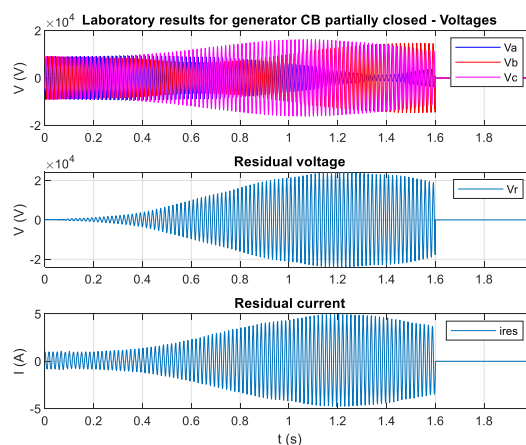
Fig. 16 Electrical network behaviour in case of generator CB partial opening – laboratory results.

Such simulations always require a critical assessment of the obtained results. The way each component is modelled can indeed lead to inaccurate outcomes and/or misinterpretation of the underlying phenomenon. This is particularly true for this event, where the phase-voltage fluctuations do not appear to be realistic. To remove any ambiguity regarding the validity of the simulation results, complementary laboratory tests were conducted on a reduced equivalent network. The behaviour was successfully reproduced, as illustrated in the Fig. 16.

This additional analysis not only made it possible to define the complementary protections to be implemented but also increased our level of confidence in the simulation of an atypical case leading to unconventional phenomena.
