# EUR18\_13 - Our Electrical people work and switch safely and we know it...

Wim de Wilt, Independent Power Consultant  
Paul Donnellan, Shell Projects & Technology

# Case 1 – what happened?

# Case 2 – Situation and background

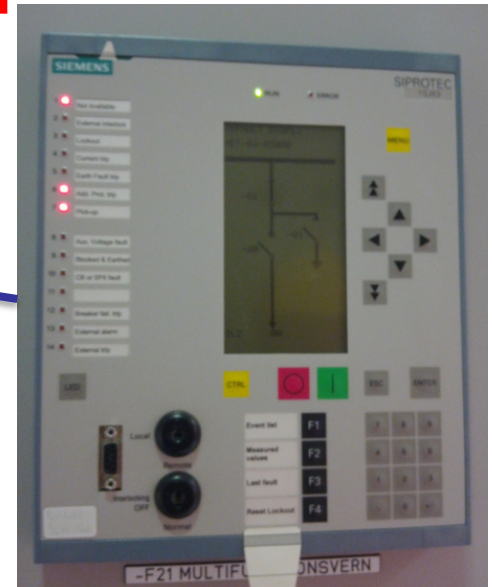
# Gas evacuation system for SF6 gas

Picture taken from the front and shows involved bus bar and switchgear with gas evacuation system connected with closed isolator.

- Work permit was activated and leader was contacted to isolate the switchgear. Leader for coupling calls Leader for safety and confirms that circuit breaker is opened (Isolator to bus bar is still closed, hence there is still power on in the compartment with the gas outside the specifications). Job with evacuating the gas was started.

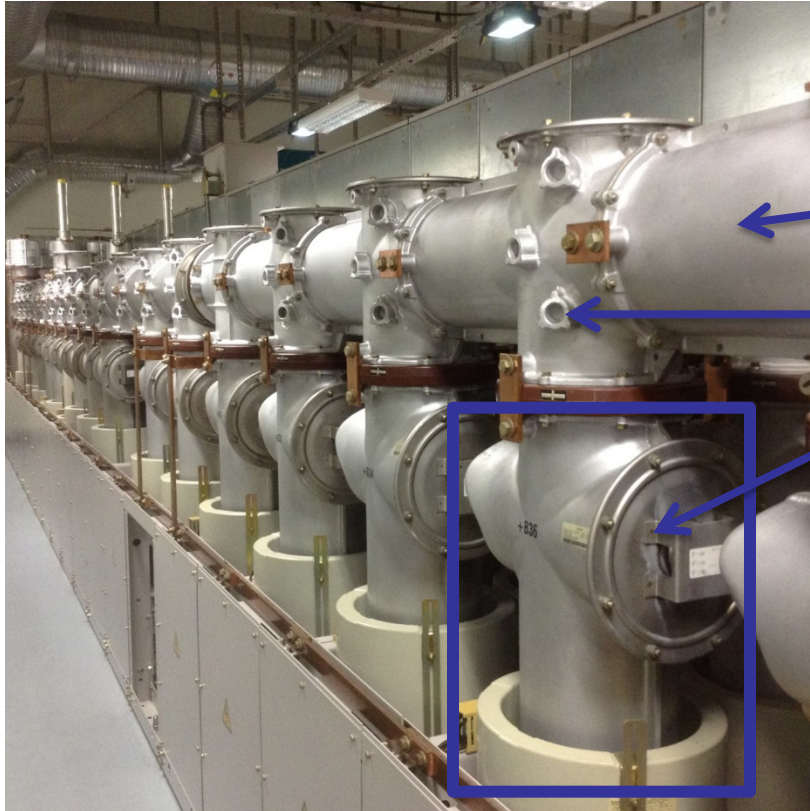
## Compartment with arc flash and pressure build up

- Picture taken from behind and shows compartment with circuit breaker involved in arc flash.

Bus bar

Isolator

Circuit breaker compartment

- After 10 minutes the compartment was almost empty an arc flash to earth occurred. This caused the bursting discs to fail and the switchboard room was filled with smoke. This caused the high voltage relay of the 22kV bus bar incomer to trip. This tripped 2 substations and the admin building resulting in a full production shutdown at the site.

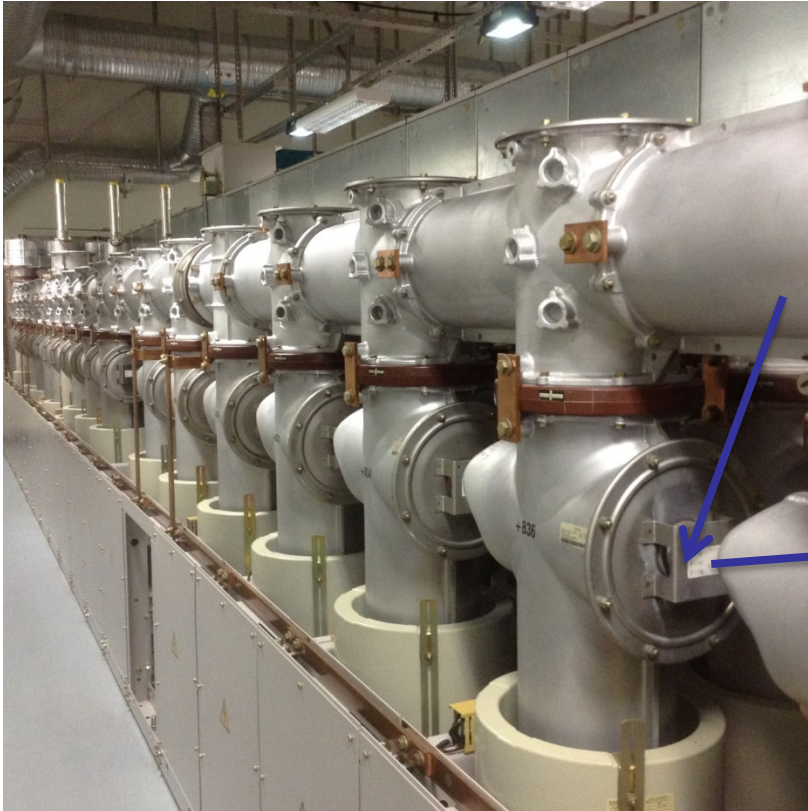
## Bursting disc to prevent pressure build up in case of SF6 leakage/failure

- Picture taken from behind and shows ruptured burst disc in the circuit breaker compartment and shows the involved bus bar and switchgear.

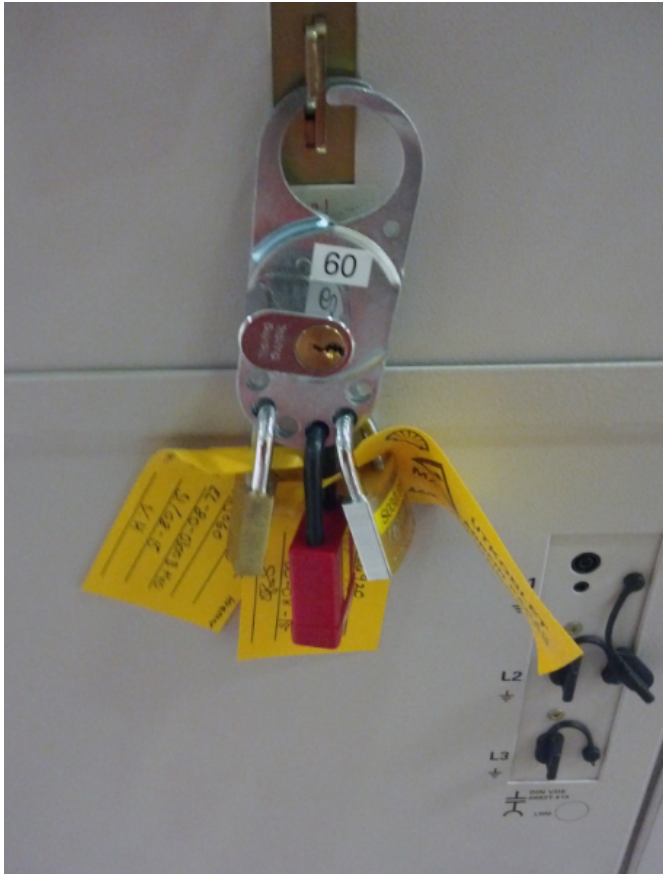
## Example of normal lock out/Tag out high voltage

- Leader for switching make switching plan
- Leader for safety carries out Lock out /Tag out and tests that equipment is “dead” (no voltage present)
- Personnel carrying out the job, put on its own padlock and verifies/ensures that equipment is dead.

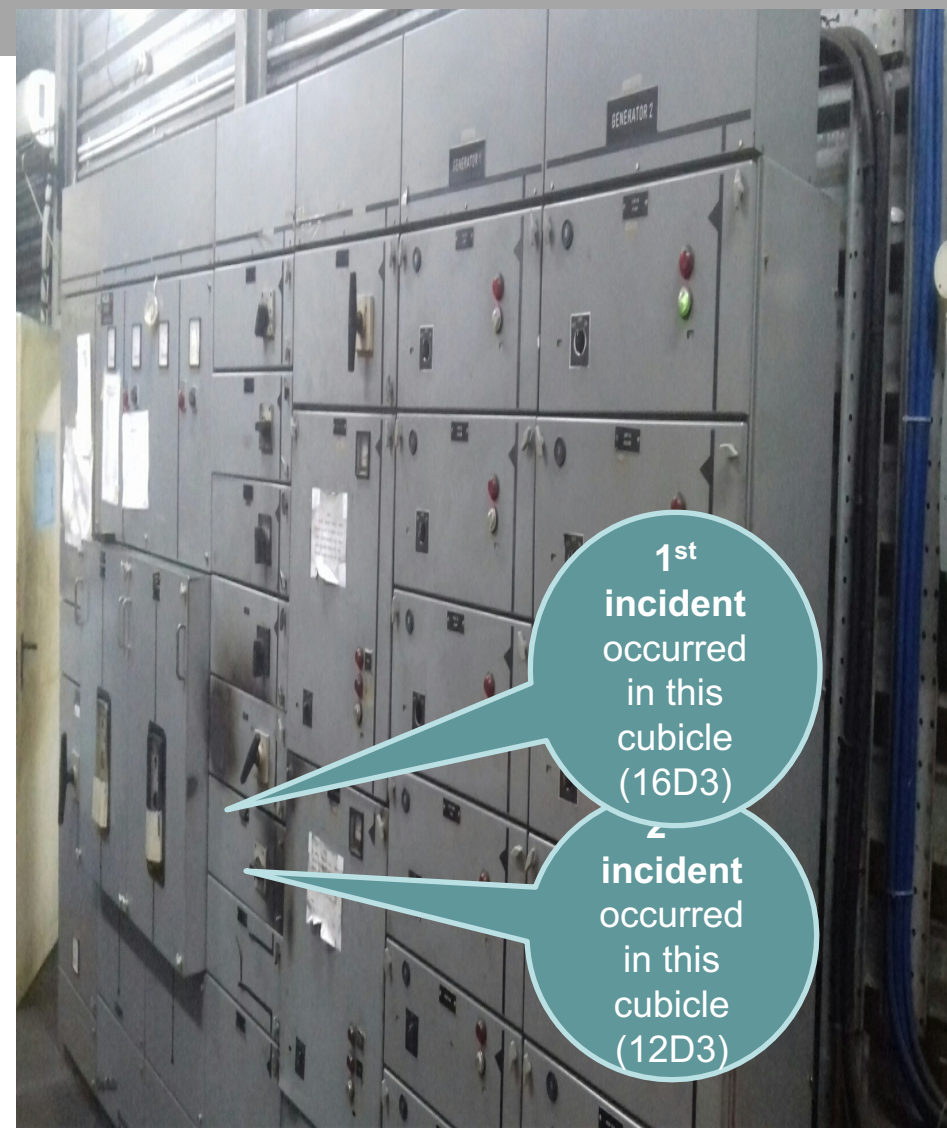
The station manager and his team of electrical technicians observed a hissing sound at the low voltage (LV) switch gear panel (1000A aged LV switchgear) located in the CPP control room. While responding to arrest the situation, a decision was made to open the LV panel cubicle.

Once the cubicle was opened, there was an electrical arc flash/explosion which resulted in various degrees of burn injuries to four personnel within the immediate vicinity. Three of the injured persons were treated in the clinic and discharged same day while the fourth person was transferred to the Specialist Burn hospital for further treatment.

An attempt to restart the plant shortly after led to a second explosion on a cubicle above the first one on the same switchboard.

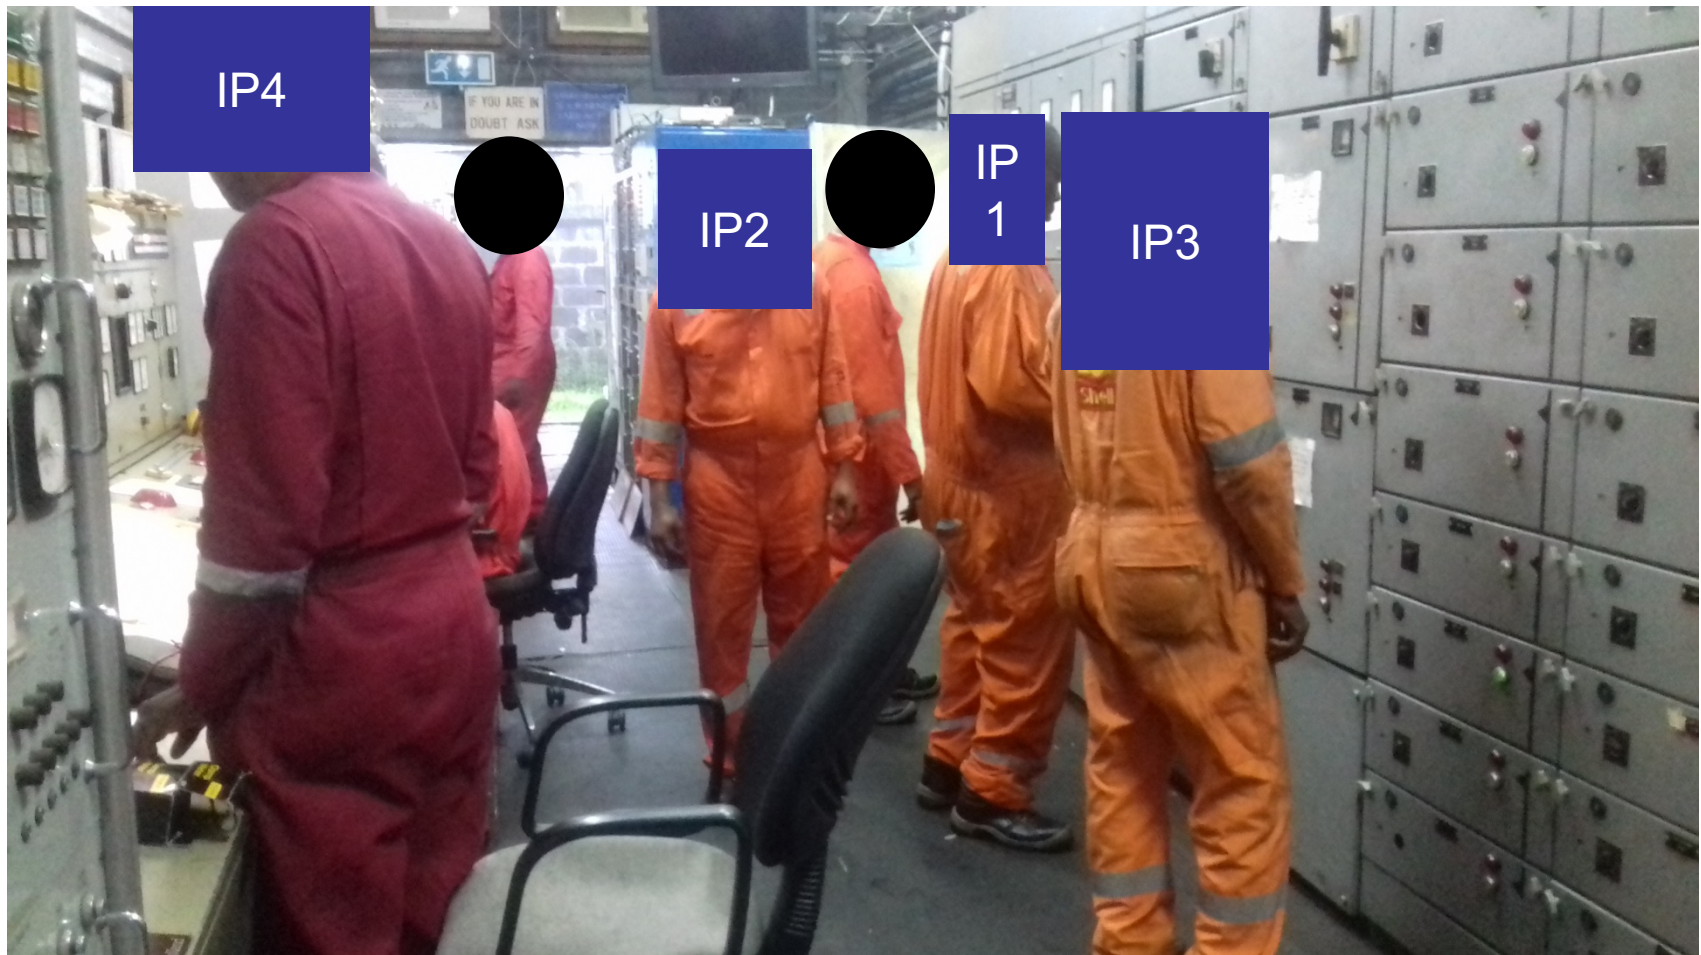
## Power Plant role play indicating positions before explosion

Note that these are not the actual persons involved in the incident.

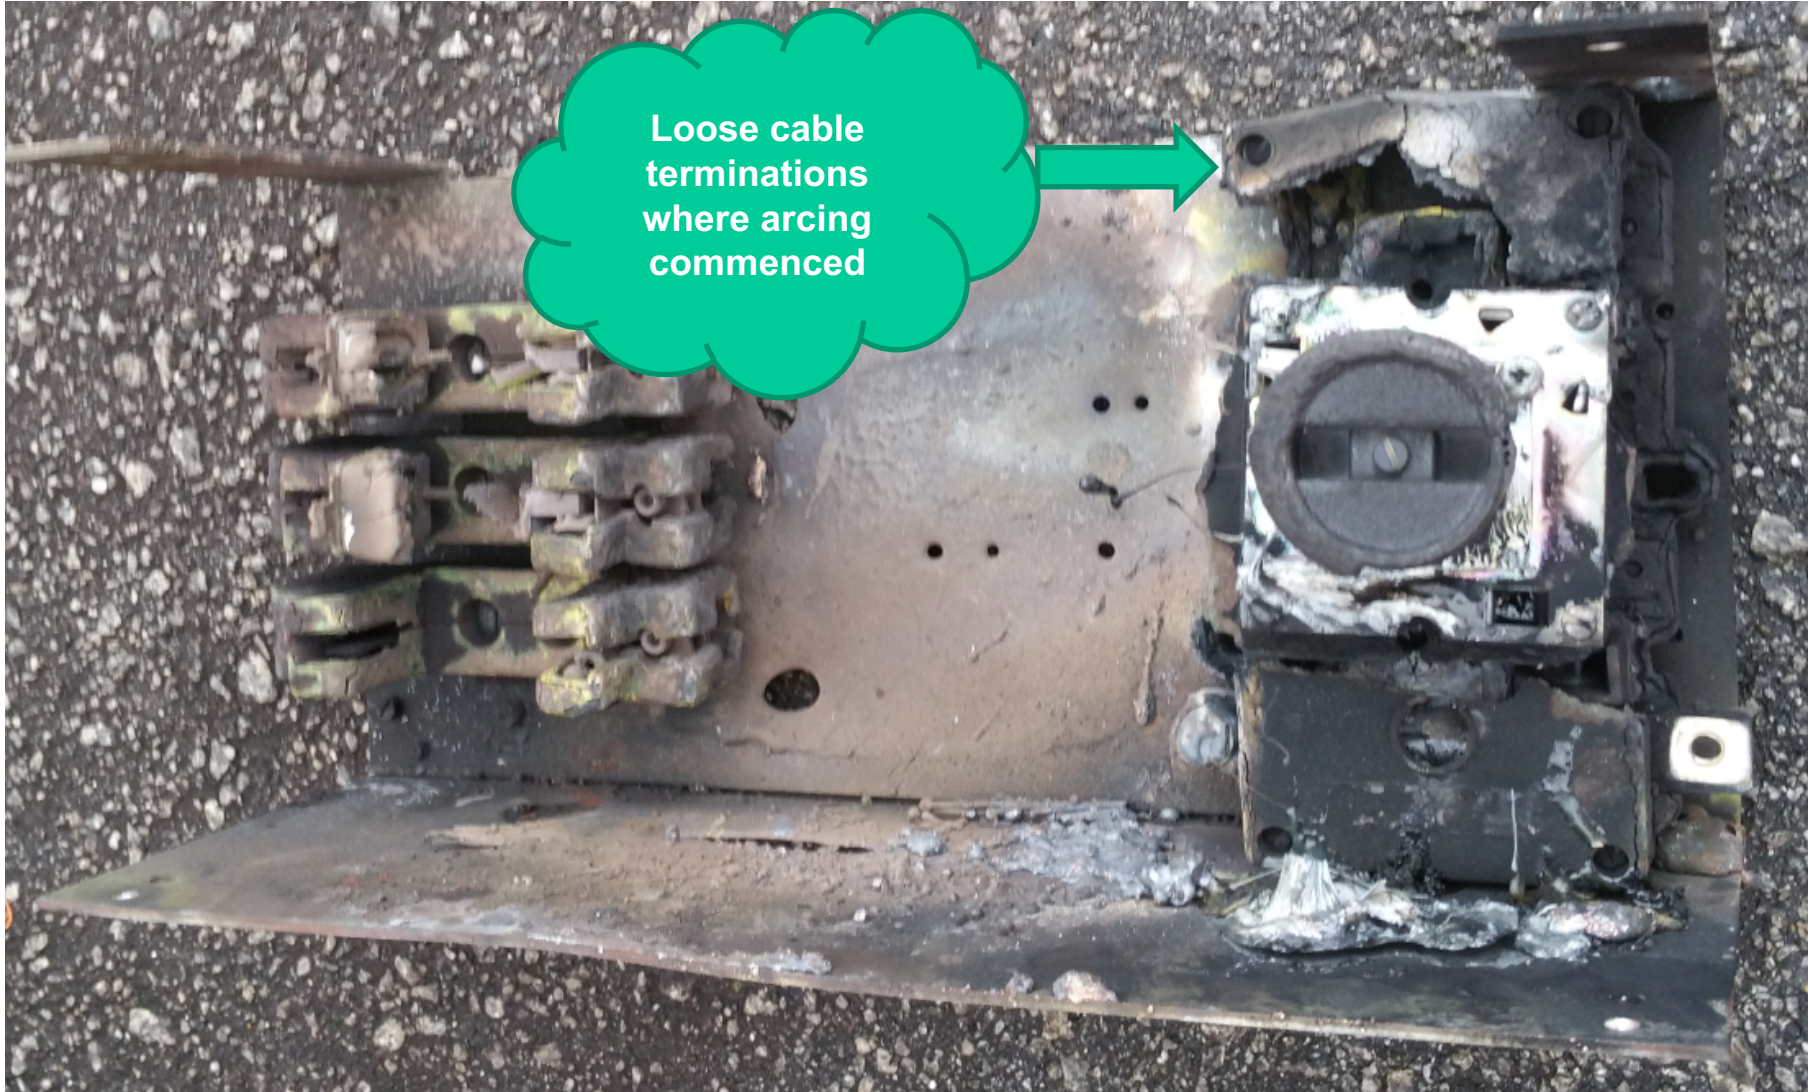
## Loose Terminal

- Arcing and burning commenced from loose cable connections to control switch for the first impacted panel
- In preparation for opening and inspection, crew personnel turned off the feeder isolator switch. This is normal practice for inspection. However, hissing sound was still heard, though damped, after turning off the feeder isolator switch.

| <b>Loose Termination</b> | <ul style="list-style-type: none"><li>▪ Inspection of the switchboard by the investigation team revealed various degrees of tightness of the cable terminations on the fuse bases and control switches in the switchboard.</li></ul> |

- When site or operating conditions become or are perceived unsafe, never hesitate to shut down the operation.
- Preventive maintenance on the switchgear including checks for loose connections and Insulation Resistance Tests is critical to assure integrity of the unit.

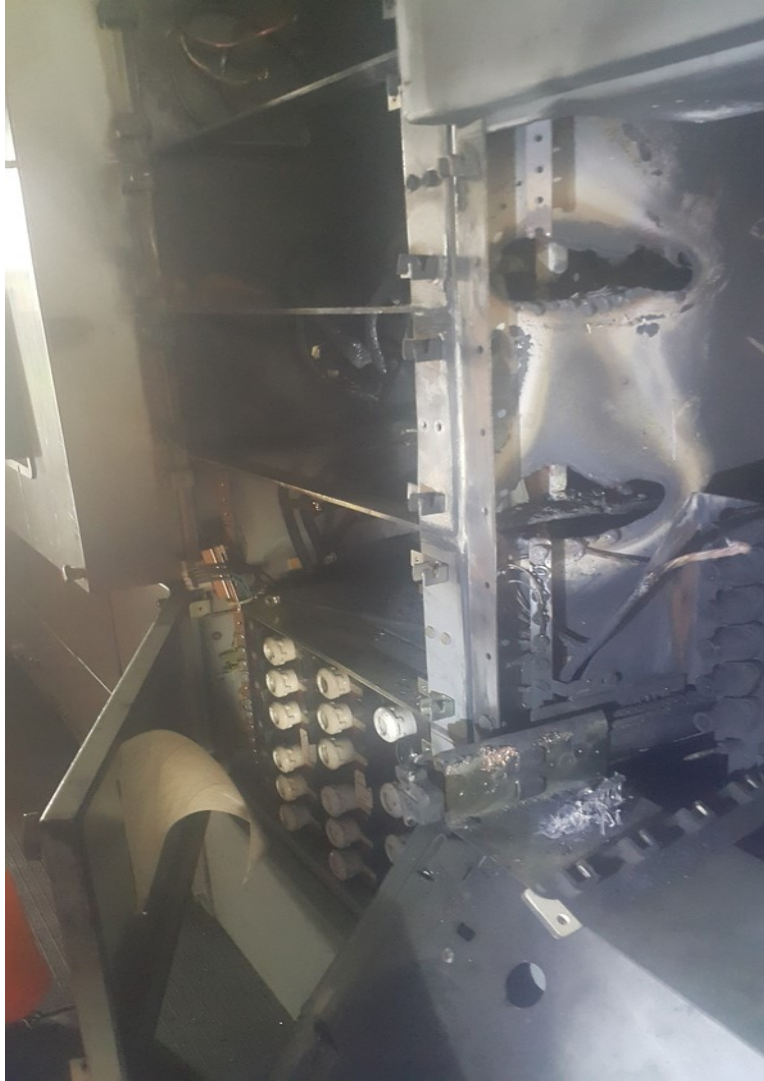
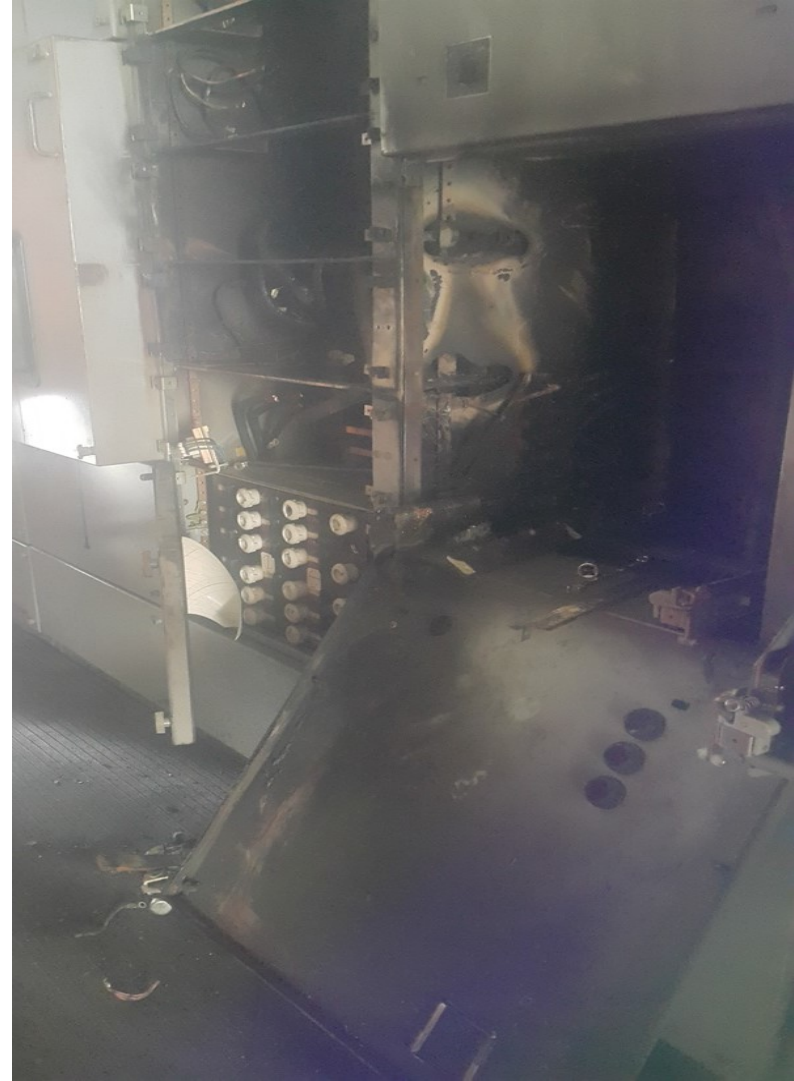
# Cover for vertical busbars burnt

- Turning off the switch and opening of the panel caused a short circuit of the phases within the connections already weakened by heat from the arcing. This led to further/rapid rise in temperature, melting of the copper bus bars and the discharge of flash and hot molten metals that impacted on the IPs.

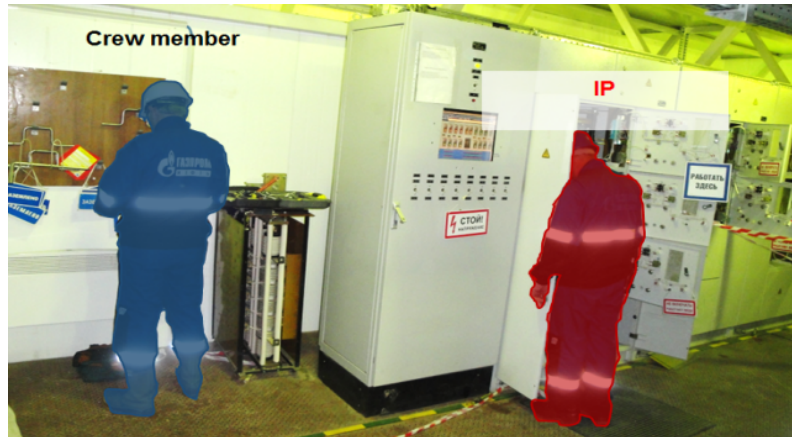
### ELECTRICAL FOREMAN SUSTAINED FATAL 10kV ELECTRICAL SHOCK

On 3<sup>rd</sup> July 2017 planned work activities for soft start switch installation were being performed in electrical switchgear room of Modular pump station #2 at the Central Processing Facility (CPF).

The electrical work party encountered difficulties installing bolts connecting the switch to bus bars.

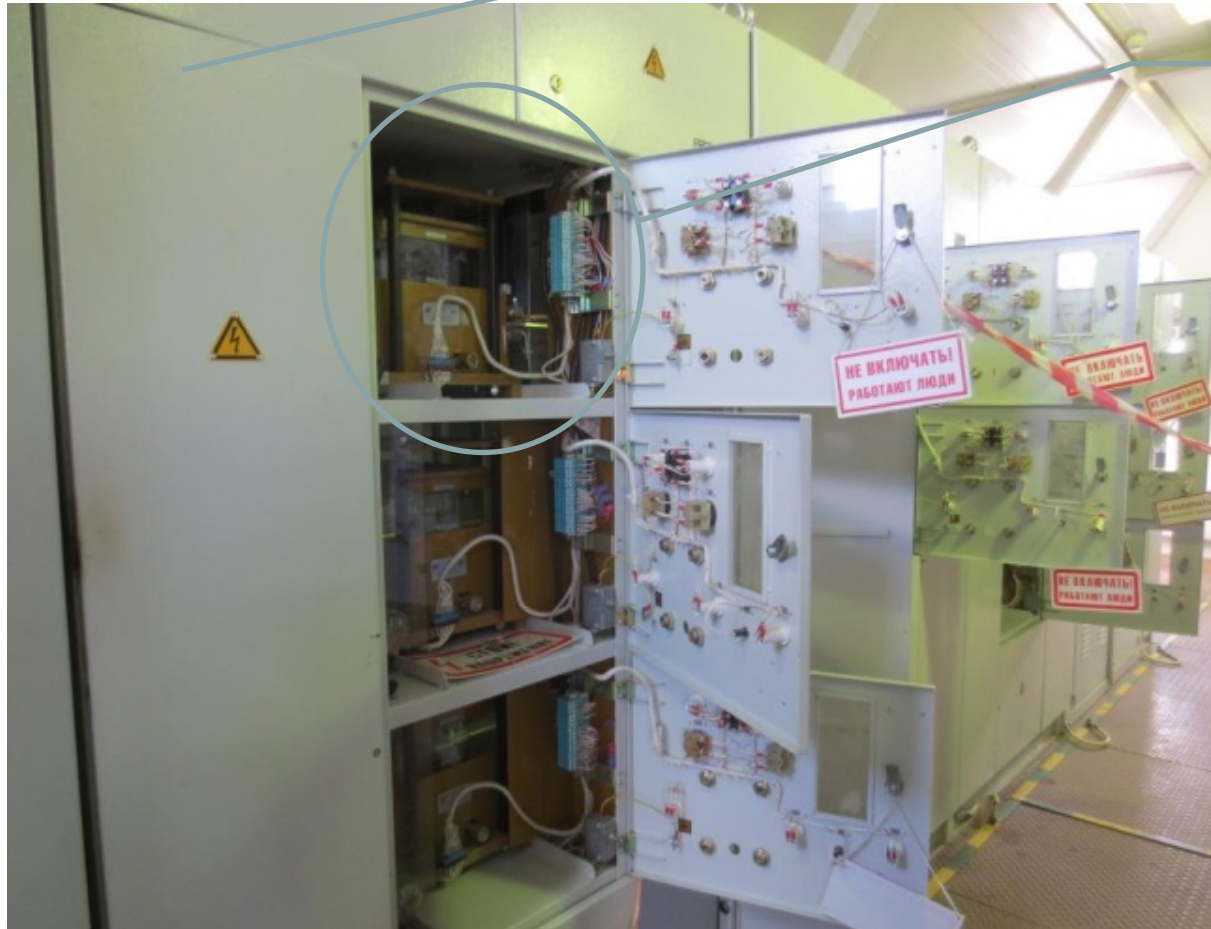
## Case 3 - Incident details

Cable compartment  
door

Work area

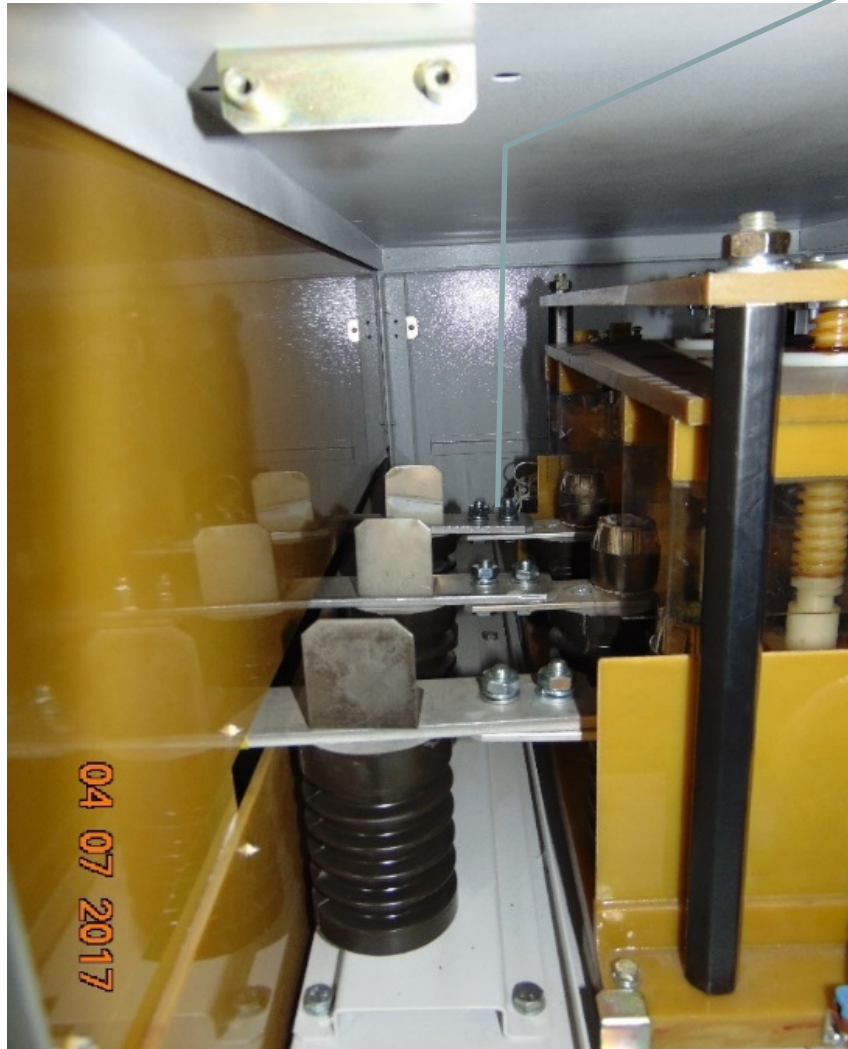
## Case 3 - Incident details

Bolted connection  
difficult to reach

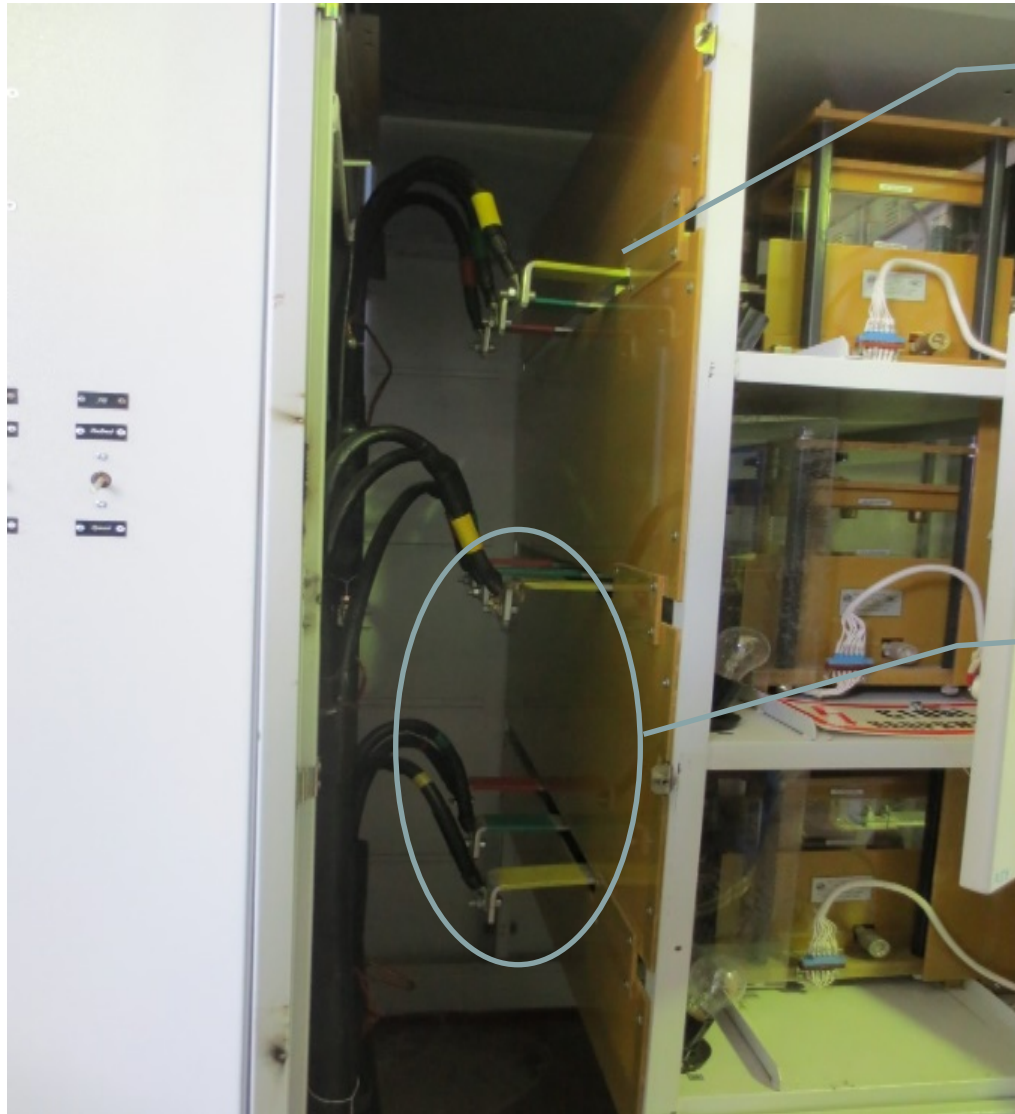
## Case 3 - Incident details

Whilst party members were locating the tool required for completion of the bolting activity the Electric foreman opened the panel door and came into contact with the live busbar with his left hand and received a **fatal electric shock**.

Isolated terminals

Live terminals

- Discussion – hierarchy issues and complacent behavior, what can you do?
- Prior to commence work on electrical installation, ensure that all power sources are isolated (performed the necessary shutdown and isolations), apply specified PPE and insulated tools
- When **ANY** conditions change in the workplace - **STOP and NEVER** continue an activity without an **APPROPRIATE and THOROUGH** reassessment the risks and gaining the **APPROVAL** to allow it to be performed safely!
- “Don't ignore” – **INTERVENE** if you observe unsafe actions of your colleague, this could save a life!
- Anything else?
