# ENHANCING ARC FLASH SAFETY THROUGH CONTINUOUS THERMAL MONITORING AND OTHER RISK MITIGATION STRATEGIES

Copyright Material PCIC energy  
Paper No. PCIC energy EUR25\_25

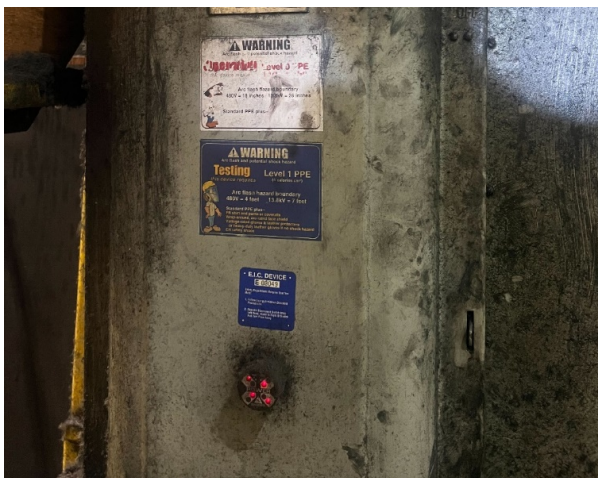
Figure 2 - Panel-Mounted PESD in Dirty Environment

Engineering controls involve redesigning equipment or systems to isolate people from hazards. In the electrical domain, this includes arc-resistant switchgear, remote racking systems, and permanent electrical safety devices (PESDs). PESDs, for instance, allow workers to verify absence of voltage from outside the panel enclosure, eliminating the need to open energized cabinets during

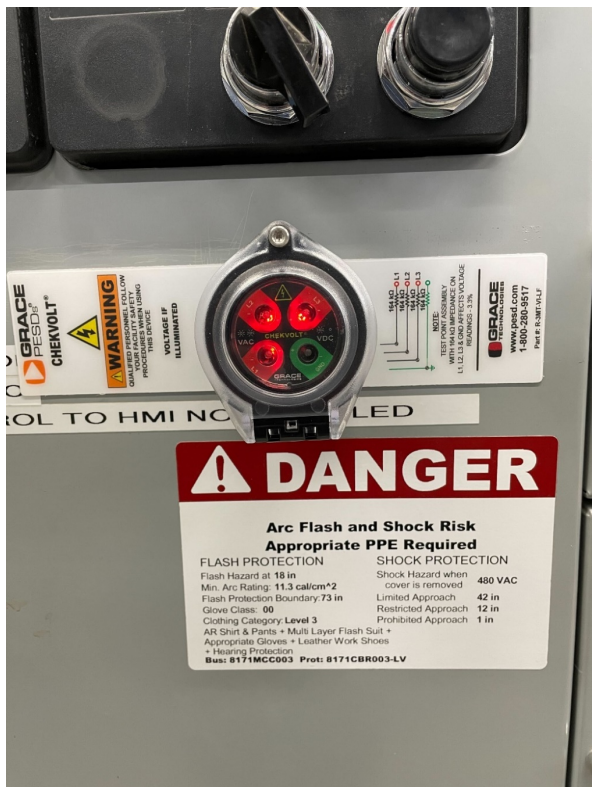
Figure 3 - Panel-Mounted PESD with Illuminated LEDs to indicate Voltage Status

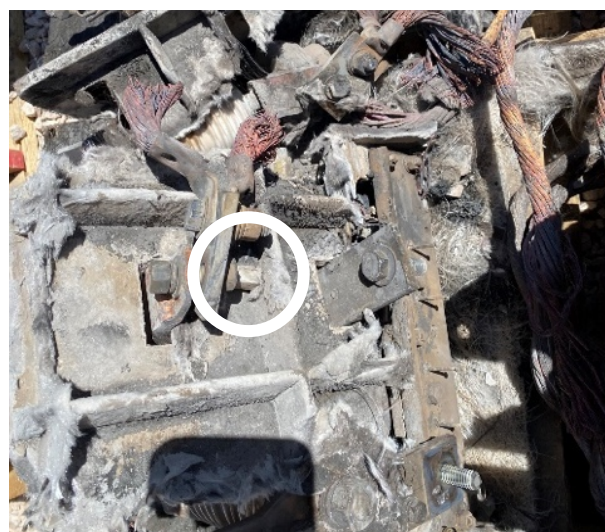
Figure 8 - B-Phase Joint Indicating Loose Connection

A failure occurred from a single, un-torqued, bolted connection on the lower B-phase termination of the upper VFD contactor (refer to Figures 2 and 3). While the other terminations on the damaged contactor were intact and tight, the lower B-phase termination was loose. The root cause of the loosened bolt was attributed to one or more of the following factors:

1. Over-torquing of the termination, causing it to fail
2. Damage to the flex connection to the contactor
3. Stress on the cable termination lug

Despite the damage, the starter remained energized, causing continued heat buildup. The contactor's glass polyester case melted, producing smoke coating the entire upper area of the PDC, approximately five feet above the floor. The resulting soot was greasy and smeared when touched. Additionally, the glastic insulating panels melted, exposing the underlying fiberglass.

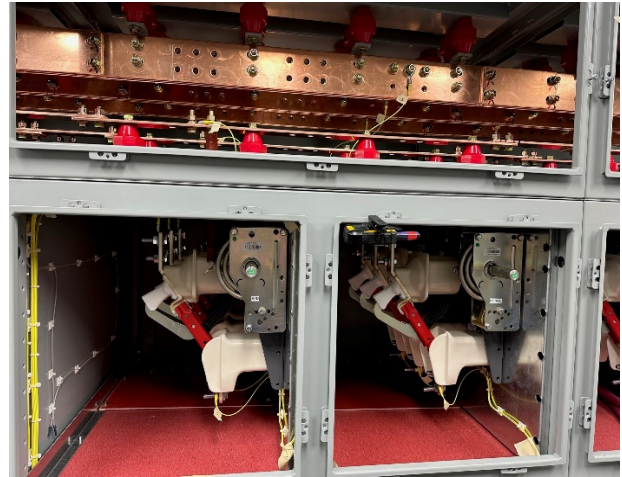
*Figure 9 - MV Drive Switchgear - Double Bus and Switch CTM Deployment*

After evaluating the alternatives, the team concluded that the addition of a CTM system would be the most effective way to ensure the integrity of all MV power terminations and 480V terminations above 100A; basing the 100A threshold on the NESC-2023 Table 410-1 incident energy guidelines. And in the end, they collectively determined the benefits of a CTM system extended beyond just detecting issues; they included real-time alarming, data trending for predictive maintenance, and significantly reducing personnel exposure to live MV energy.
