LESSONS LEARNED THROUGH COMMISSIONING, LIVENING, AND OPERATING SWITCHGEAR: PART 2

Copyright Material PCIC Europe
Paper No. EUR24_08

Abstract—The 500 MW expansion of a facility’s power system, incorporating 12 000 protective relays and modern technologies in a radial scheme and a breaker-and-a-half scheme, requires special attention. Potential errors during the constructing, commissioning, livening, and synchronizing of new facilities with an existing power system can lead to safety incidents and/or a loss-of-production event to the existing facility.

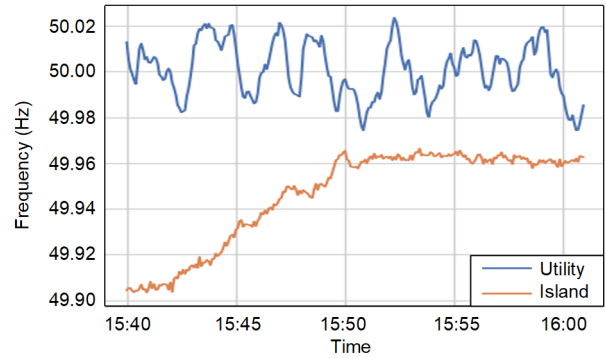
Fig. 2 Autosynchronization initiated

At approximately 15:40 local time, the autosynchronization test was initiated. As expected, the controller sent speed raise signals to the participating GTG until the island's frequency was within 0.05 Hz of the utility's frequency, as shown in Fig. 2. However, unexpectedly, the controller also sent multiple voltage lower commands to the AVR of the participating GTG. Quickly after autosynchronization began, at 15:41:30, the dispatchers received a low terminal voltage alarm from the participating GTG. The autosynchronization controller continued sending voltage lower commands, eventually lowering the central substation bus voltage from 111.5 kV to approximately 110.6 kV, as well as triggering a low-low alarm for generator terminal voltage at 15:44:52. The team soon realized that the utility voltage shown on the

dispatcher console is measured from the primary (utility-side) of the BT, whereas the autosynchronization controller is comparing the substation bus voltage to the secondary (facility-side) of the BT (refer back to Fig. 1). Indeed, the BT's tap, which is manually operated by power operations, was not in the 1:1 transformation ratio position, resulting in a significantly lower secondary voltage, as shown in Fig. 3. As such, the controller correctly tried to lower the island voltage.

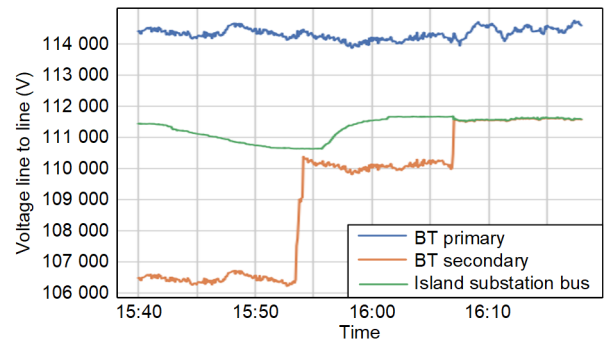
Fig. 4 Successful synchronization

After the team realized the problem, the dispatchers adjusted the tap position on the BT until the BT secondary voltage was closer to the substation bus voltage and returned the participating GTG back to a typical terminal voltage. The team reinitiated the autosynchronization, which sent no further GTG signals since the island voltage and frequency were now within the closing range. After waiting for the angle difference to come within the closing range, the system closed the utility breaker, and the facility was resynchronized, as shown in Fig. 4.

- Ensure the operating procedure begins with verifying the BT tap changer position, and, if necessary, change the tap position such that the BT secondary voltage is within a synchronizable range.
- Add a communications link to display both the utility-side and facility-side BT voltages on the dispatcher console.
- Add a blocking signal from the generator secondary control system to block autosynchronization raise or lower signals for an individual GTG if terminal voltage limits would be exceeded. (The transmission of a similar blocking signal from the governor had already been configured if speed or real power limits would be exceeded.)

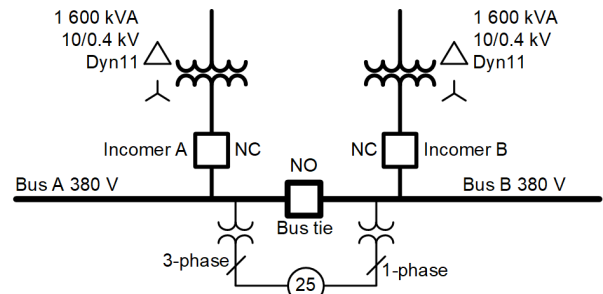
Fig. 8 Two delta-wye transformers energizing an MCC

Two 10 kV delta to 380 Vac wye transformers energize MCC incomers separated by a normally open bus tie. Both transformers were independently commissioned. During precommissioning, the 380 Vac incomer (either Bus A 380 V or Bus B 380 V in Fig. 8) was energized via a temporary generator. This permitted energizing downstream loads off the MCC to aid in commissioning activities. As the electrical commissioning neared completion for both the transformers and MCC, preparations were made for each transformer to be energized by the permanent supply. This is often done a week or two apart from the final activity of verifying the manual transfer scheme, which consists of a closed transition that is achieved by closing the bus tie and then opening the selected incomer. In the process of performing the manual transfer, the normally open bus-tie breaker cannot close. See Fig. 8.

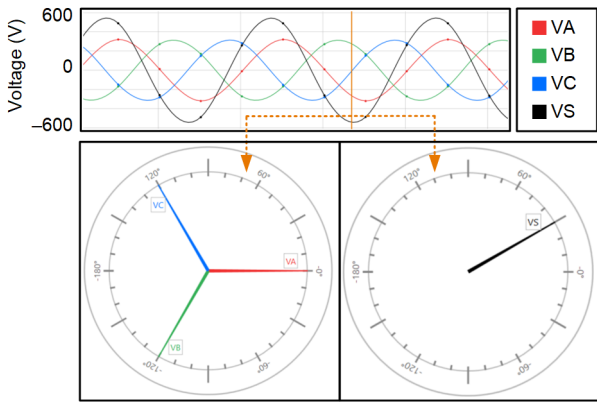
Fig. 10 Bus-tie relay expected phasors

To quickly verify the expected phase angle, the commissioning team opened Incomer B and closed the bus-tie breaker. In this state, an event report was captured from the bus-tie relay to confirm the expected synchronizing voltage phasor. See Fig. 10 for expected phasors.

In reviewing the installation in detail, the commissioning team found that the delta links on the 10 kV transformer winding were installed incorrectly on Incomer B. See Fig. 11 for a typical installation showing the delta link placement (photo taken during precommissioning).

With the incorrect delta link configuration, all three-phase voltages were 60 degrees out of phase. With both incomers energized, under normal conditions, the voltage across the open contacts is 0 percent of the phase-to-ground voltage. However, with the incomers 60 degrees out of phase, the voltage across the open contacts was 100 percent of the phase-to-ground voltage. See Equation (1) based on the actual synchronizing phasor in Fig. 9 and the expected synchronizing voltage in Fig. 10. While this voltage difference is no different than having one energized source and one de-energized source, the problem is the short-circuit current interruption. If operators attempt to close a normally open tie circuit breaker with two out-of-phase sources, there will be significant transient current between the two sources, which may exceed the capability of the circuit breaker to interrupt out-of-phase currents [4].

- As seen in the incorrect delta link event, operators should trust the relay sync permissive and determine the root cause before moving forward. It was important to verify that both incomers' transformer secondary sync voltage did not align and pointed toward the Incomer B transformer delta links as the root cause.

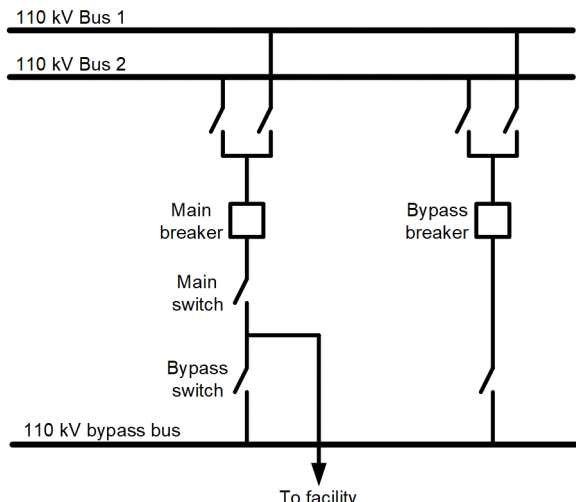
Fig. 13 Simplified utility single-line diagram

The bus configuration at the utility substation is a double-bus single breaker with an additional bypass bus, as shown in Fig. 13 with key breakers and switches labeled. In this configuration, the line can be fed from either Bus 1 or Bus 2 when both the main breaker and main switch are closed, or fed from the bypass bus when both the bypass breaker and bypass switch are closed. The main breaker, bypass breaker, and switch statuses are wired to the line protective relays on the utility side. The breaker and switch positions are then transmitted to the facility-side line protective relays through the line current differential channel and finally transmitted to the fast load-shedding system via a serial communications channel between the facility line protective relay and the fast load-shedding system. No direct communication occurs between the fast load-shedding system and any of the equipment on the utility side. Additionally, due to the limited bandwidth available on the dedicated line current differential, the status of the utility breaker was sent as a combined “both open” and “either closed” signal. The combined “both open” and “either closed” logic generated in the utility line protective relay is shown in Fig. 14.

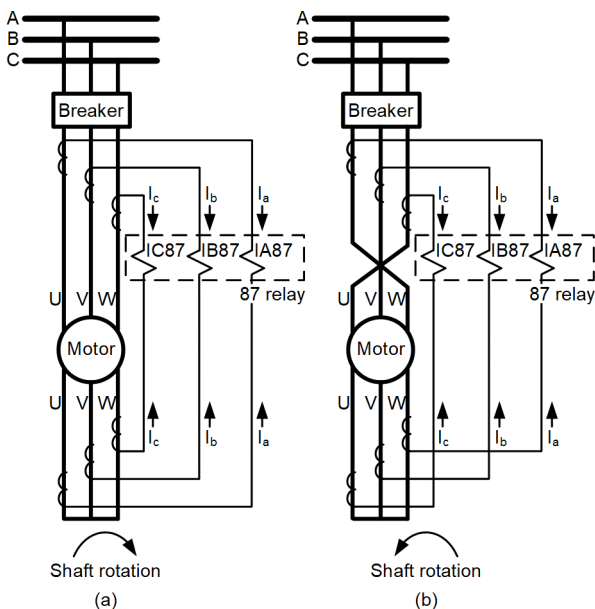
Fig. 16 (a) Clockwise and (b) counterclockwise rotation of the power system connections

In Fig. 16, the application intent was for the rotor to rotate in the counterclockwise direction. As a result, the motor terminal U connection needs to be the power system C-phase, the motor terminal V needs to be the power system B-phase, and the motor terminal W needs to be the power system A-phase. Instead, the commissioning team found the motor wired to the power system as identified in Fig. 16a and needed to reconnect the motor to the power system as identified in Fig. 16b. When multiple problems are found during commissioning, it is important to treat each one independently and to recognize that the solution may impact the other problem. In this case, when modifying the primary leads to the motor terminals, the commissioning team had to change the CT connections on the neutral end accordingly so that A-phase on the medium-voltage breaker side aligns with Terminal W on the motor's neutral end. Incorrect CT wiring was not the root cause of the differential trip.

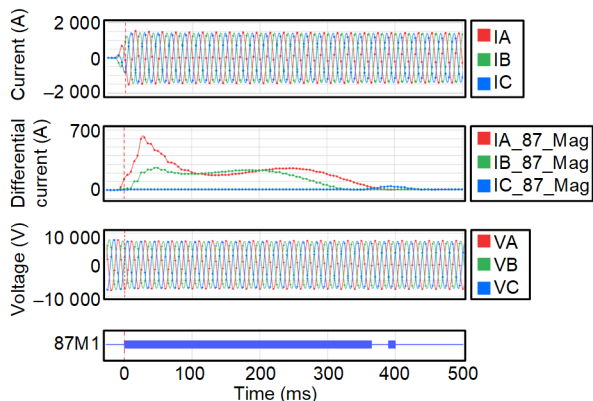
Fig. 19 Successful start filtered event report

The differential current waveforms in Fig. 17 and Fig. 18 are classic signs of dissimilar CT performance. After a discussion with engineers, it was agreed to extend the 87 differential start pickup trip time to 500 ms and maintain the existing set point to permit a start. With the relay set to generate an event report when the 10 kV breaker changed state, the following waveform was captured during the successful start. Fig. 19 shows the filtered event report. In this case, the motor successfully started, but the false 87 differential current lasted for 364 ms. To make the relay secure during start, the starting differential element needs to account for this expected fault differential current. From the relay's sequential event report and motor start report, the motor remained in the starting state for approximately 2.5 s during this uncoupled run. From motor nameplate information, however, a normal coupled load start for the motor is expected to take 9 to 17 s, depending on the voltage (100 to 80 percent nominal voltage, respectively).

Over the course of the next 2 to 3 months, several similarly sized 10 kV DOL motors were started. All motor relays captured similar false differential current. Event reports were captured for all starts and compared. For the worst-case scenario, the starting differential element remained asserted for over 700 ms. Phases involved in the false residual current appear random. However, they are specific to the point on wave when the motor was energized. Engineers reviewed the event reports and observed that the false differential current was approximately 50 to 60 percent of the locked-rotor amperes (LRA) of the machine. As a result, the starting differential pickup and trip delay were changed to 3.35 A secondary with a trip time delay of 0.2 s. While this was much shorter than the observed 700 ms maximum with the original 0.2 A secondary pickup, it was determined appropriate with the increased pickup to 3.35 A secondary. In addition, while sensitivity was reduced during the motor start, it was determined appropriate based on other active motor protection elements.

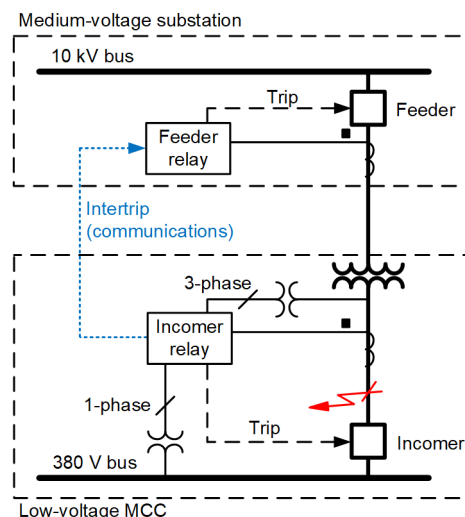
Fig. 20 380 V Incomer/Bus B simplified single-line diagram

Fig. 20 depicts the simplified single-line diagram of the system. The incomer protective relay is wired to measure phase currents from a current transformer installed upstream to the incomer circuit breaker. This relay receives three-phase voltage from the line side of the circuit breaker and single-phase (sync-check) voltage from the bus side of the circuit breaker. This figure also depicts the location of the arc-flash event based on the post-fault inspection of the MCC.

Upon an intrusive post-event inspection of the MCC, copper shavings, which were hardly visible during the general visual inspection, were found at the rear of the circuit breaker busbar connections. The copper shavings were suspected to be left over from a retrofit installation of a voltage transformer on the busbar, which occurred in the fabrication yard where the module was constructed. There were threaded holes drilled on the busbar to accommodate installation of the voltage transformer. Fig. 21 shows the drilling point on the copper buses for the installation of the new voltage transformer. Many copper shavings were found inside the breaker compartment. It is suspected that one of the shavings fell down on the busbar due to breaker jolt while closing and resulted in the arc-flash event.

opening of the LV side breaker will not interrupt the current and the medium-voltage side breaker shall be tripped. This condition is depicted in Fig. 20.

- The arc-flash event root cause came down to proper housekeeping. It is critical to clean up any debris that accumulates during the construction and commissioning phases.
