# Co-Simulation: Unlocking Advanced Approaches to Electrical Incident Analysis

Copyright Material PCIC energy  
Paper No. PCIC Europe EUR26\_24

Julien Mécréant  
Schneider-Electric  
Grenoble  
France

**Abstract** - Ensuring electrical reliability is key for Oil & Gas facilities, where process continuity and safety are essential. While outages are rare, when they occur, root cause identification is complex due to multiple interacting factors. Immediate restoration takes priority, leaving incomplete data for post-event analysis.

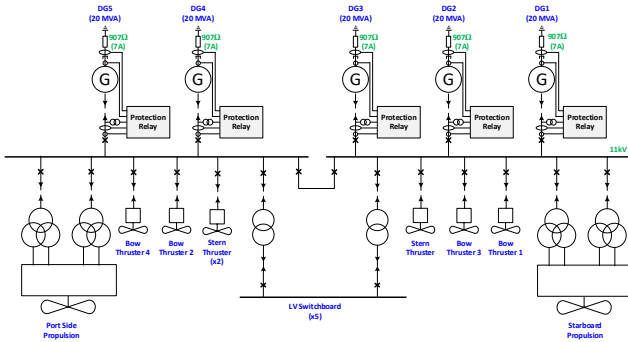
Fig. 1 Simplified single line diagram

The vessel is powered by five medium-voltage DGs (Diesel Generators), each rated at around 20 MVA. The installation is divided into port and starboard; each composed of one half-busbar interconnected by a normally closed tie. Propulsion, harbour-manoeuving thrusters, and MV/LV (Medium Voltage / Low Voltage) transformer feeders connect on each half-busbar. Upon a failure on one side, the tie opens to feed the entire installation from the healthy side. Each generator neutral is grounded through a resistor limiting earth-fault current to 7 A per generator (resulting in 7 A to 35 A current limitation depending on the number of generators in service).

Before the incident, four DGs were online (DG1 to DG3 on starboard side, DG4 on port side), one generator was offline (DG5 port side) and the tie was closed. The vessel had just left harbour.

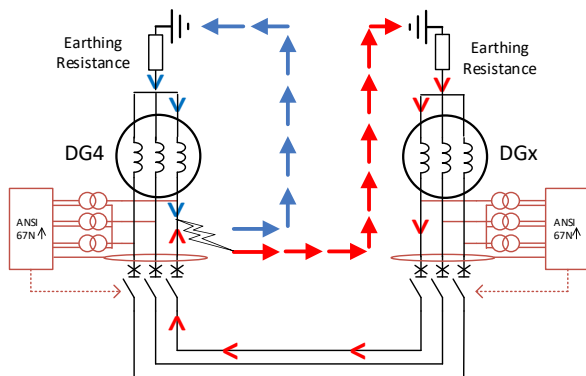
Fig. 2 Earth fault current circulation

In the event of an earth fault on generator DG4 (left-hand generator in Fig. 2), two main contributions to the earth fault current coexist: the first contribution originates from the earthing of generator DG4 itself. This fault current component is not measured by the DG4 ANSI 67N protection. The second contribution originates from the earthing of the other generators in the system (denoted DGx in Fig.2). The additional contribution of the network capacitive current (not represented on Fig. 2) could also be considered.

As a result, the CBCT on each DGx cables detects the residual current corresponding to its own earthing contribution, while the CBCT of generator DG4 detects the

residual current resulting from the combined contribution of all the other generators DGx.

Since the directional element is set with a direction toward the generator, only the DG4 ANSI 67N operates. This ensures selective tripping with the other generators, thereby maintaining continuity of service for the remainder of the installation: the remaining generators took over DG4 load smoothly. Then DG5 was started and connected, and the installation ran normally for more than 13 hours, suggesting the situation was under control.

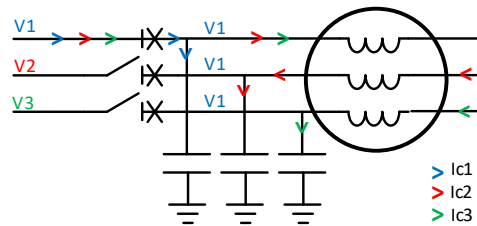
Fig. 8 Motor equivalent electrical circuit

At first glance, a simplified motor model fed on one phase only cannot alone explain the phenomenon: unenergized phases would not carry current without a return path, so zero-sequence voltages cannot appear at the breaker primary. But the consideration of parasitic phase-to-earth capacitances provides a consistent explanation.

Each parasitic capacitance is charged to the same voltage  $V_1$ . The resulting per-phase current is as follow.

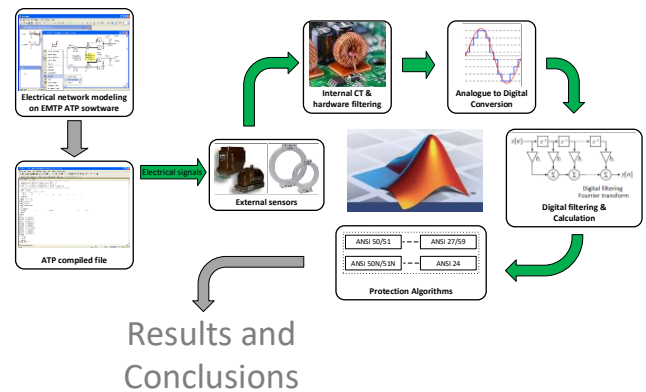
Fig. 11 EMT-ATP & Matlab co-simulation principle

The EMT-ATP simulated signals were then fed to a MATLAB digital model including CT (Current Transformer) & VT sensors models, acquisition chain of the protection relay (hardware, Analogue-to-digital conversion, Digital signal processing (numerical filtering, Harmonic 1 calculation...) and protection algorithm and tripping logic (especially ANSI 24 protection for this case).

Simulated tripping times were compared with customers logs and fault recordings to check the consistency when attempting to reconnect single generator.
